SRR-89-02

Load Test and Evaluation of the 18th Avenue Bridge

Ministry of Transportation

Bridge:	18th Avenue Bridge in the Town of Markham, MTO Site No. 37-104
Type of Bridge:	One-lane, single-span concrete slab-and-girder bridge
Posted Load:	8 tonnes
Span/Width:	9.14 m/5.59 m
Angle of Skew:	0°
Date of Test:	October 23, 1986
Test Engineers:	A. Agarwal, J. Maheu
Job Captain:	J. Klubal
Supervisor, Instrumentation:	B. Kwok
Test Load Applied:	Central Loading: 2 axles: 41 tonnes 4 axles: 56 tonnes Eccentric Loading: 2 axles: 36 tonnes 4 axles: 50 tonnes
Responses Measured:	Longitudinal strains in the beams and deck at midspan and near the abutments, transverse strains at the bottom of the deck at various locations between the beams, strains across diagonal cracks in the beams at the west abutment, vertical displacements at midspan, and horizontal movement at the abutments.
Conclusions:	Posting loads may be increased to 16, 20, and 29 tonnes for evaluation levels 1, 2 and 3, respectively. If traffic were to be restricted to the central portion of the bridge, these could be raised to 20, 26 and 35 tonnes. These posting loads are based on the assumption of re-evaluation within 5 years.

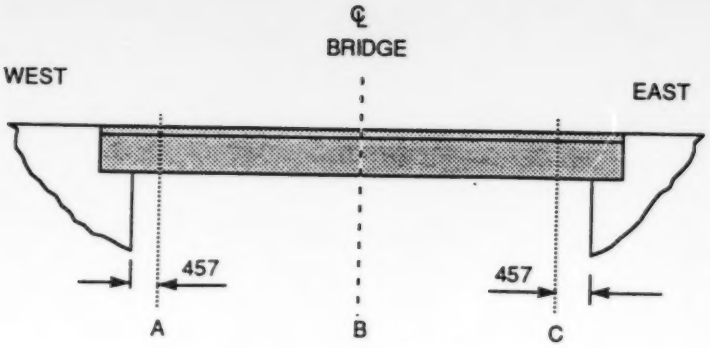
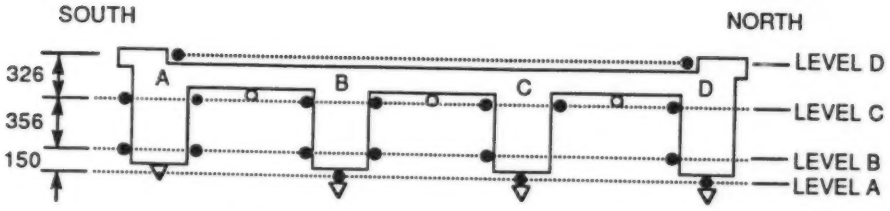
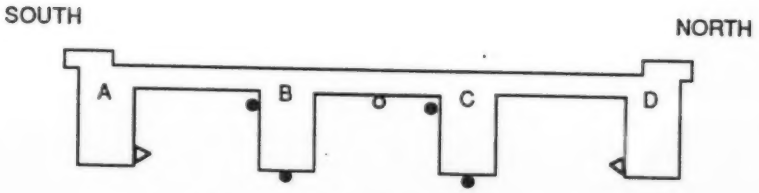
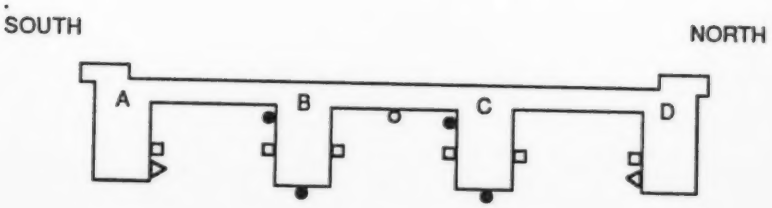
Figure 4/ Details of Instrumentation

The bridge was instrumented to measure longitudinal strains, transverse strains, crack openings, vertical deflections and horizontal displacements at various locations. Figure 4(a) identifies those sections at which transducers were mounted. Section B, the midspan section was heavily instrumented to monitor the longitudinal flexural strains at various levels in the girders and deck slab at the locations shown in Figure 4(b). Transducers at the top of the slab were limited to those locations near the curb which would not interfere with the movement of the test vehicle. A strain transducer could not be mounted at the bottom of girder A due to the poor condition of the concrete and steel. Transverse strains in the bottom of the slab were measured midway between the girders. Vertical deflections of each girder were also measured at this midspan section.

Strains were also measured in the interior girders at Sections A and C near the abutments. These were intended to measure the degree of fixity or bearing restraint, as were the horizontal movements of the exterior girders at the abutments. The locations of these transducers are shown in Figures 4(c) and (d). In addition, strain transducers were mounted at right angles across the diagonal cracks near the west abutment at the locations shown in Figure 4(d).

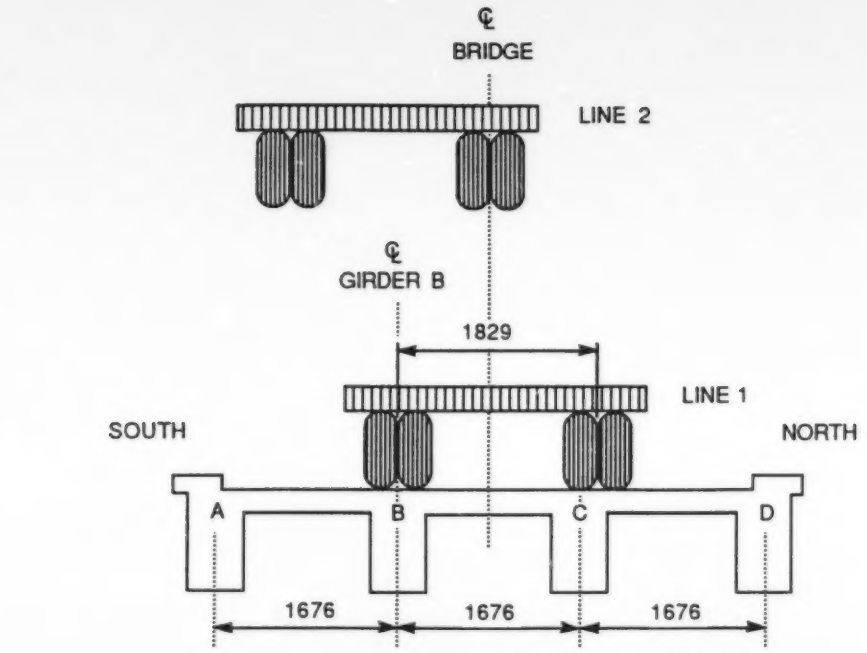
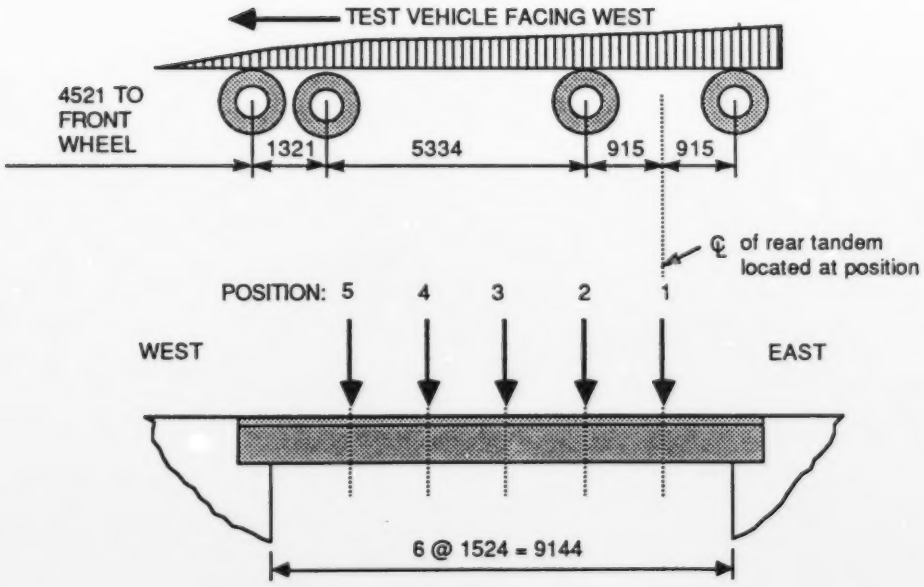
Figure 5/ Details of Loading

The geometry of the test vehicle and its transverse and longitudinal positions on the bridge are shown in Figure 5. Because of the short span, flexural effects in the bridge were governed by the rear dual axle loads and loading by concrete blocks was concentrated at the rear of the truck. Maximum shear occurred under the combined effects of both the front and rear tandems. Table 1 lists the axle spacings and weights at the different load levels. Load level 7 represents the largest load normally applied to the rear tandem of the test truck during a bridge test.

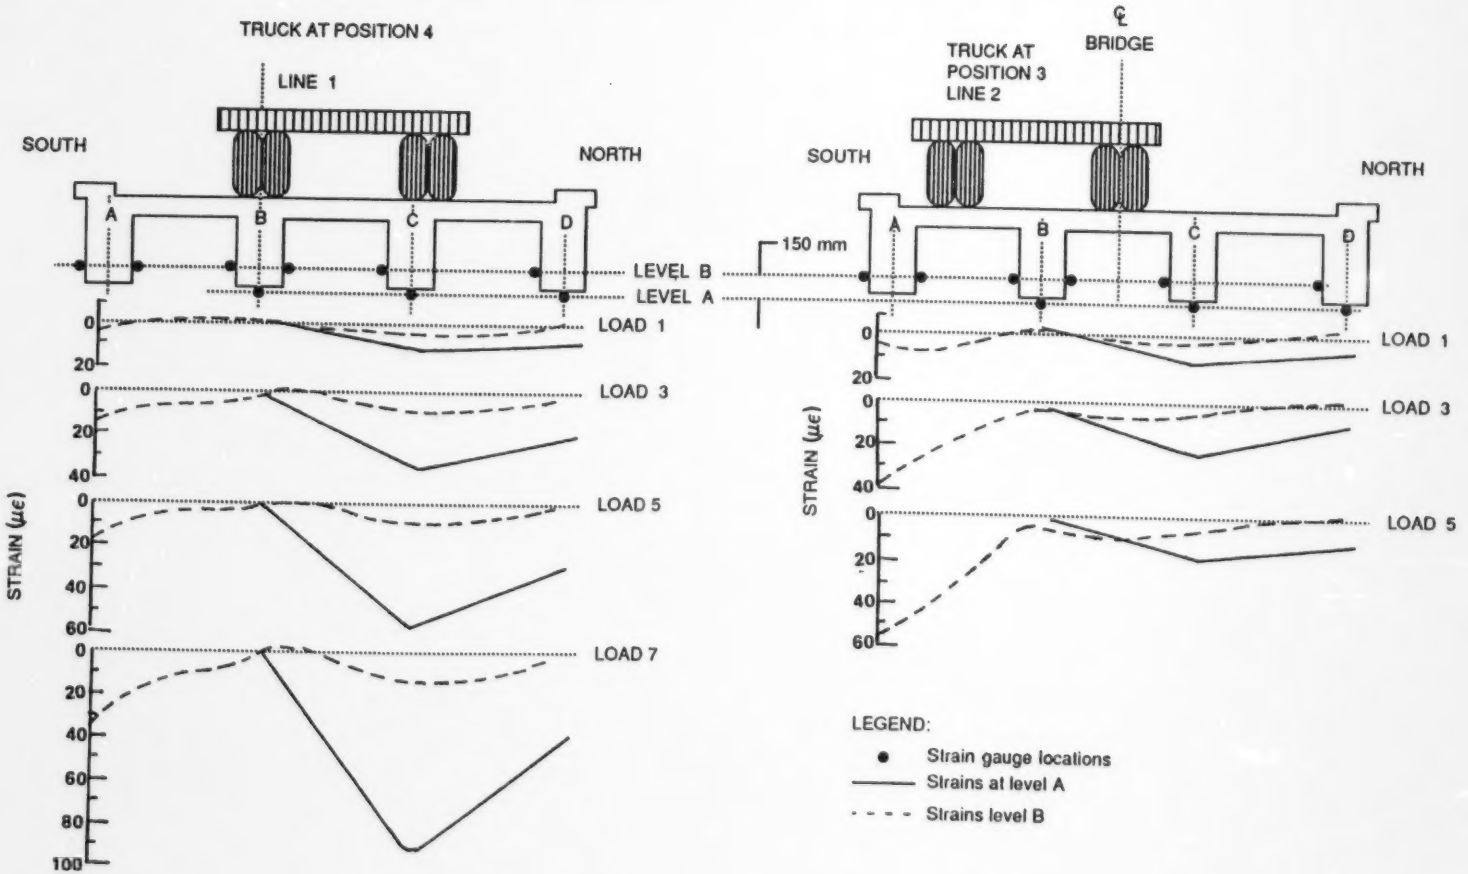
Figure 6/ Transverse Distribution of Tensile Longitudinal Strains at Midspan

An indication of the transverse distribution of load is given by the plots of tensile strains in Figure 6. These suggest a highly irregular distribution, with girder B registering negligible strains under all loading configurations. Measurements of tensile strains in concrete may be misleading since cracks may or may not be included in the distance covered by the strain transducers, and tensile strains would be larger at crack openings. However, the only midspan location where significant compressive strains were measured was on the top of the deck near the south exterior girder as seen in Figure 7.

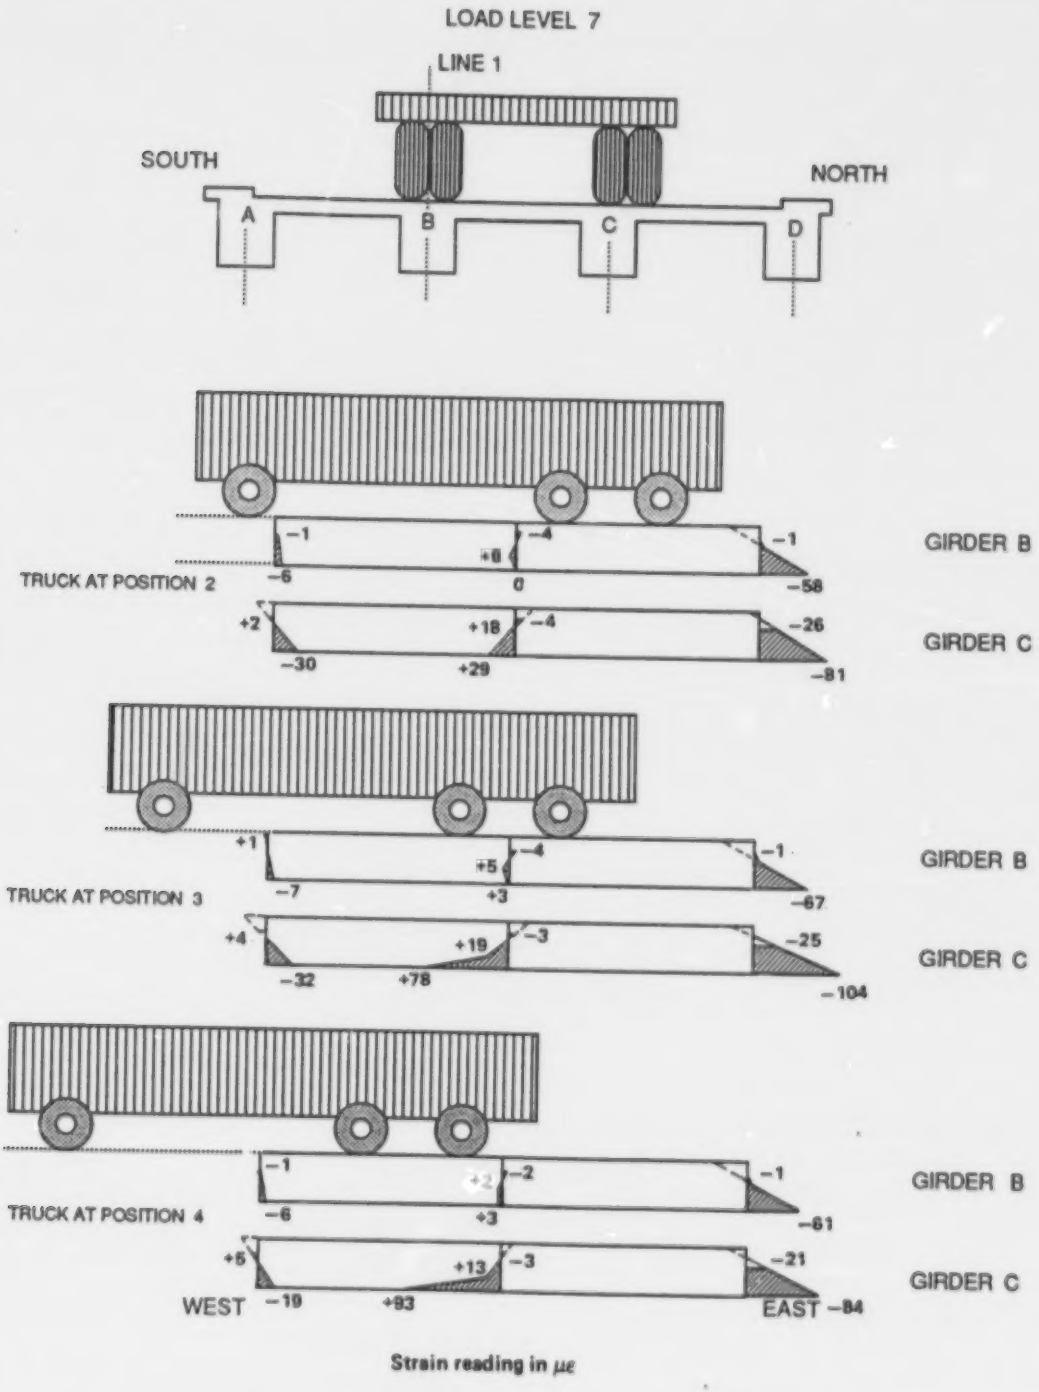
Figure 8/ Longitudinal Strains Along Interior Girders

In contrast, the largest flexural strains in the interior girders were measured in girder C, the northerly girder. However, these were tensile strains only and a direct comparison may not be valid. Longitudinal strains were also measured in the interior girders near the abutments. These are plotted with the midspan strains in Figure 8. Both girders resisted negative bending moments at the supports with larger strains measured in girder C than in girder B, and in both cases, larger strains at the east abutment than at the west. These indicate some rigidity against rotation. The cracking observed at the west abutment would provide a partial release from this rigidity, explaining the smaller strains developed at that end. Measurements of horizontal movement of the exterior girders at the abutments were negligible under all loading conditions, providing further evidence of the support rigidity.

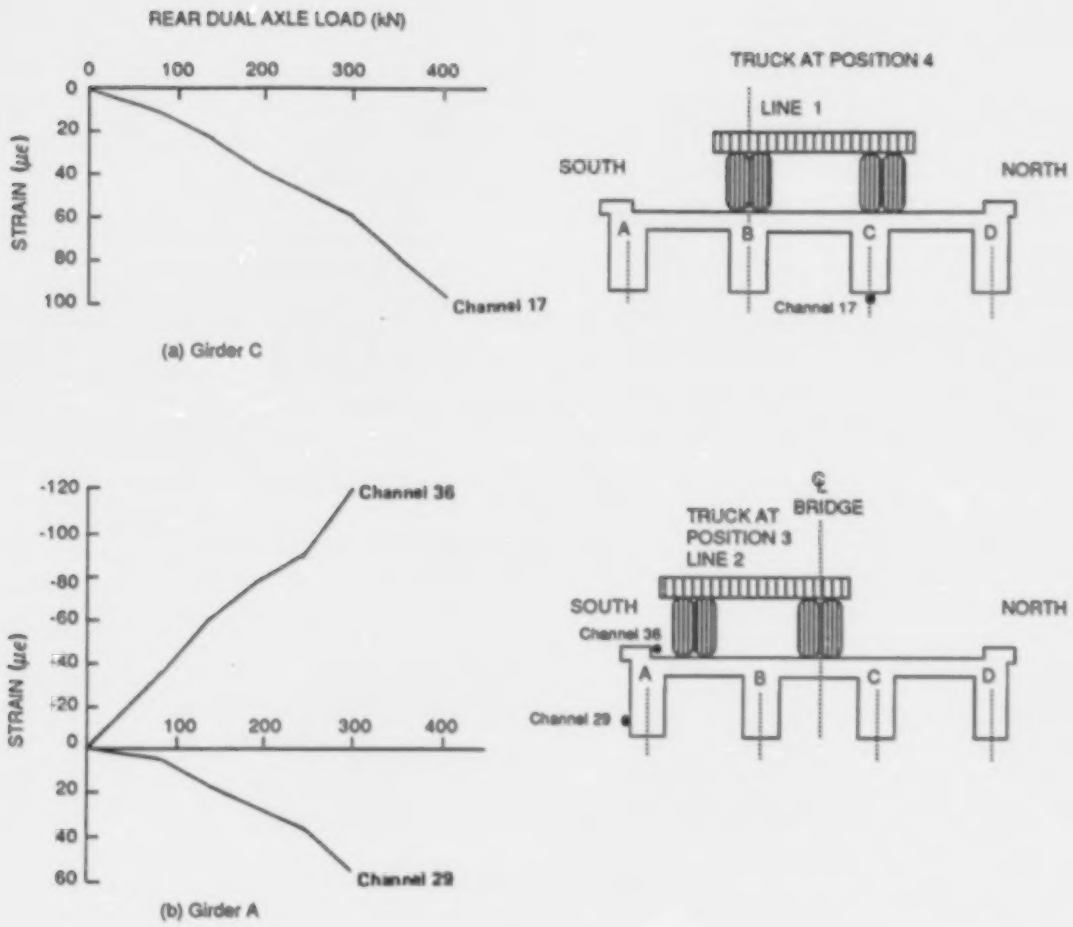
Figure 9/ Longitudinal Strains vs. Applied Load

The largest longitudinal strains are plotted against applied load in Figure 9. The maximum strains in interior girder C occurred under central loading, while those in exterior girder A occurred under eccentric loading. In each case the tensile strains become non-linear at higher loads, but were mostly recoverable. The largest tensile strain measured was 93 $\mu\varepsilon$, and the largest compressive strain -114 $\mu\varepsilon$.

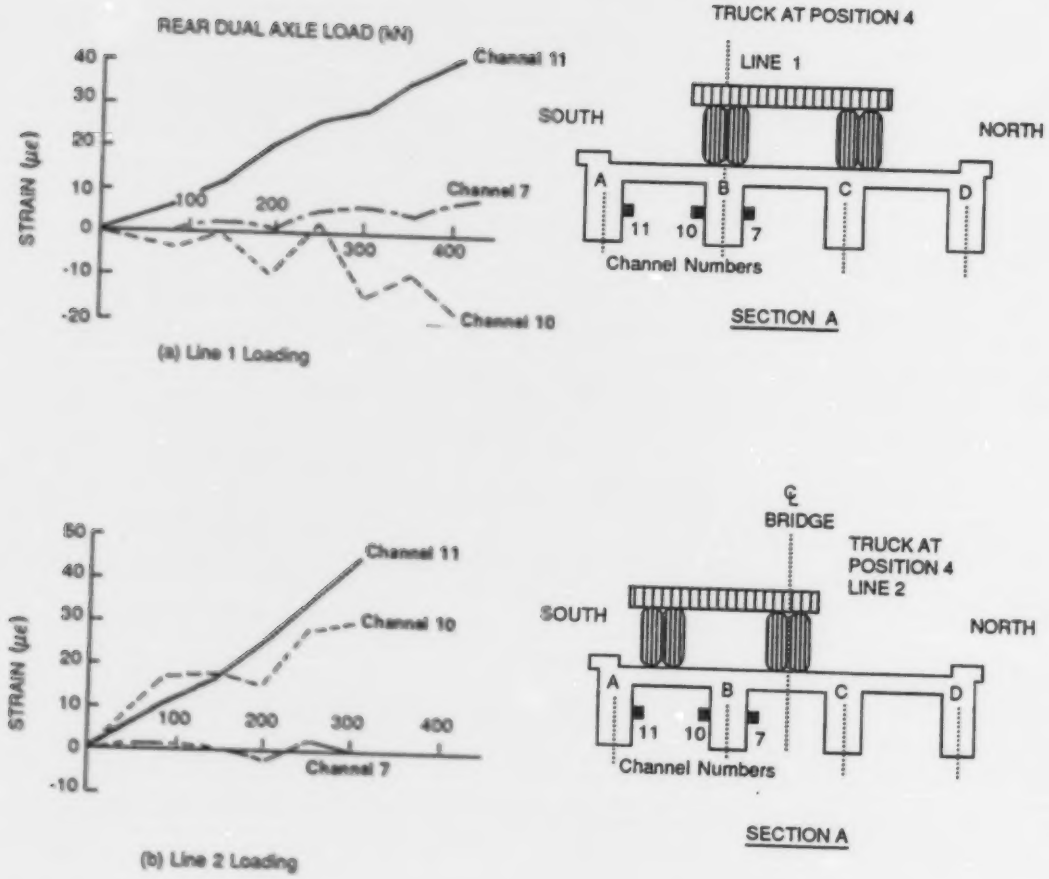
Figure 10/ Strains Across Diagonal Cracks

The strains measured across the diagonal cracks at the west abutment give an indication of the opening or closing of those cracks. As seen in Figure 10, these strains were generally small and they were fully recoverable. The largest strains were measured at the inside face of girder A. If the maximum measured tensile strain of 42 με was largely concentrated at the crack, it would represent a widening of the crack of approximately 0.008 mm based on a 200 mm long strain gauge.

The strains in girder B are evidence of the combined actions of vertical shear and torsion at the supports. Under central line 1 loading there appears to be a clockwise twisting of the girder at the west abutment with the crack on the north face (channel 7) opening and the one on the south face (channel 10) closing. The direction of the twist is reversed under eccentric line 2 loading.

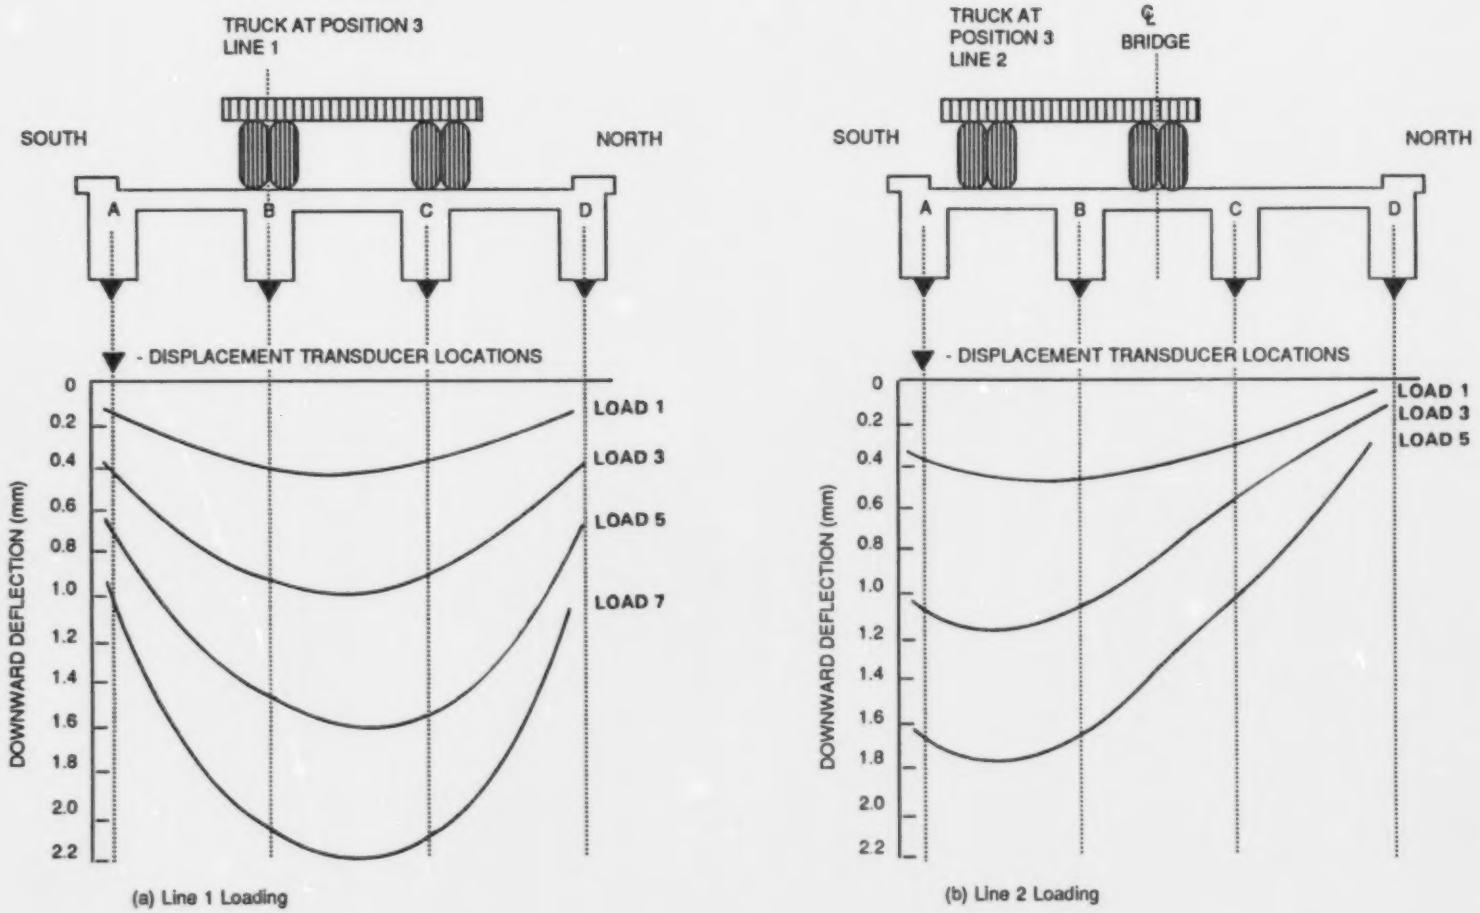
Figure 11/ Vertical Deflections at Midspan

Midspan deflections under different loading configurations are plotted in Figure 11. The patterns generally conform to the transverse position of the truck. Although the deflections of girder B are somewhat less than those of girder C under central loading, they are of the same order of magnitude. Under eccentric loading girder B deflects most as would be expected. These deflections contradict the distribution of strains measured at midspan (Figure 6), which implied that girder B resisted little or no load. However, as mentioned in Section 4.1, tensile strains in concrete may not be a reliable indication of the load being resisted due to the random distribution of cracks. Significant strains could occur across a crack while neglible strains are recorded in the concrete adjacent to the crack. Deflections are a more reliable indication of load distribution since they are related to the accumulative strains over the length of the beams.

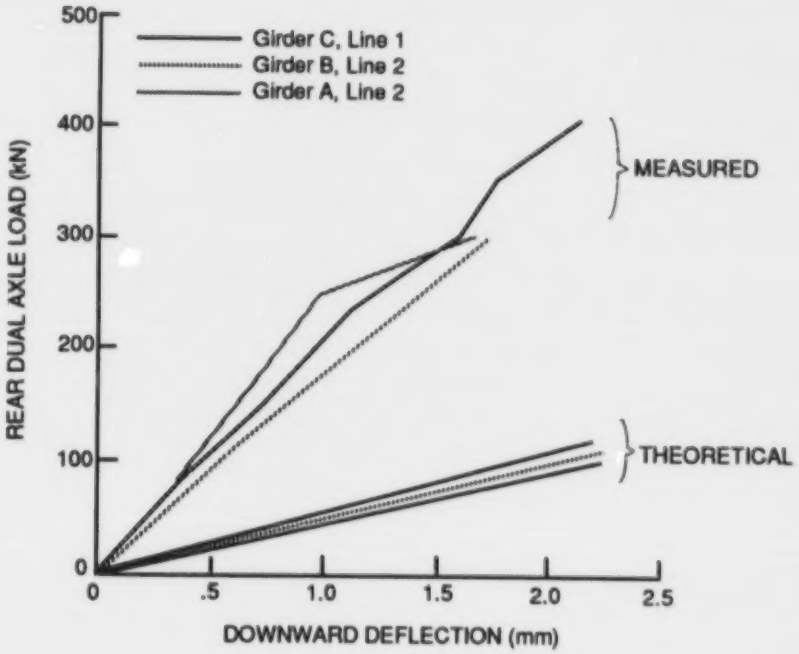
Figure 12/ Load vs. deflection

The maximum deflections are plotted against applied load in Figure 12. The measured deflections were much smaller than the theoretical values calculated from a grillage analysis program assuming a simply supported span and stiffnesses based on the full uncracked concrete section. However, the deflections in exterior girder A under eccentric loading showed signs of becoming non-linear at load level 5. Strains in this girder also appeared non-linear and for these reasons eccentric loading was stopped after load level 6. However, all deflections were largely recoverable.
